LAKE ENHANCEMENT PROGRAM
FEASIBILITY STUDY
FOR
BEAVER CREEK RESERVOIR

THE CITY OF JASPER
MUNICIPAL WATER UTILITY
607 Jackson Street
Jasper, IN 47546

Donan Engineering Co., Inc.
RR 3 Box 40H
Jasper, IN 47546

Revised:
October 19, 1990

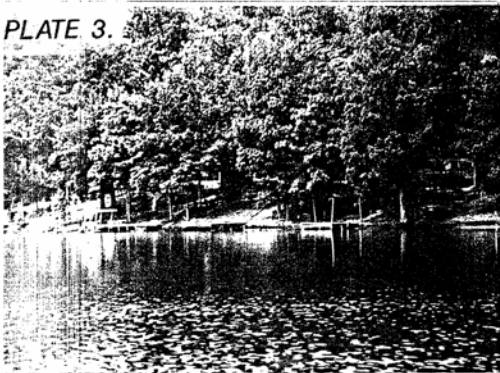
PLATE 3.

<u>PLATE</u>	<u>PHOTO #</u>	<u>DESCRIPTION</u>
1	1	Third finger facing south from boat ramp.
	2	Cattail, naiads, and algae near boat ramp.
	3	Floating algae and submerged naiads.
	4	Cattail, bulrush, sedge, and naiads near boat ramp.
2	1	Fourth finger near delta, sedges and bulrushes in foreground.
	2	Continuation of photo #1.
	3	Looking south at fork of fingers 1 and 2.
	4	Shore erosion close-up from photo #3.
3	1	Recreational development along shoreline.
	2	Recreational development along shoreline.
	3	Public pit toilet at boat ramp.
	4	Abandoned school bus and trailer on city property.
4	1	Soybean field along tributary of first finger looking north-northeast.
	2	Outhouse and wash-out area along access road on city property.
	3	Abandoned fuel oil tank on city property.
	4	Abandoned 55-gallon drums on city property.

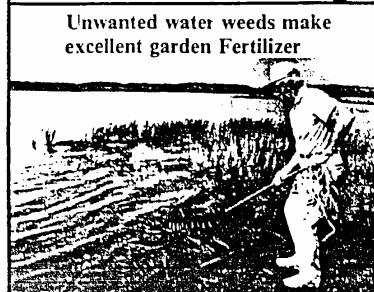
ATTACHABLE FOAM FLOAT
for removing Weeds & Algae
that float.

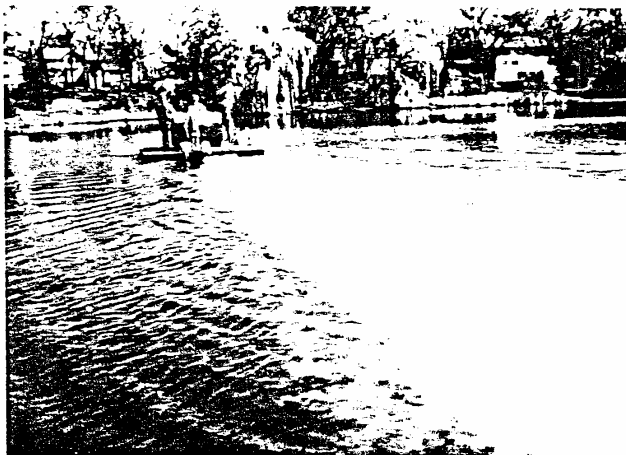
To properly blanket the lake bottom, the vessel must make precise transits of the lake. In small lakes, shoreline markers guide the vessel. Large lakes demand more sophisticated means: buoys or shore-based sonar, for example. The visible white

precipitate that forms in the wake also aids navigation on calm days by marking the last path treated.

If enough alum is added, a thick precipitate layer will coat the bottom, sealing the sediments and inhibiting phosphate return to the water column. Laboratory and on-site tests determine the quantity of alum needed to form this protective coating.

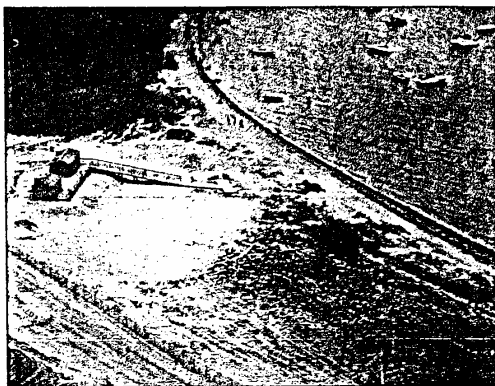
Hart Miller Island, Chesapeake Bay, Maryland. Island location and poor soil conditions prevented other types of restroom facilities. Clivus was the solution.

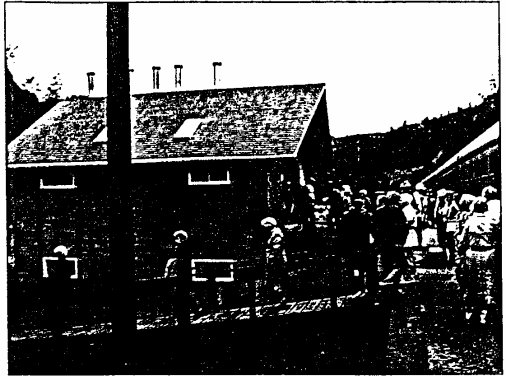
Agoma Central Railway, Agawa Canyon Park, Ontario. A high seasonal use restroom facility with Clivus recycling systems and a Clivus-designed grey-water system handles the 1,000 daily uses from May through mid-October.
